New Construction vs. Renovation Analysis

Harriman, Architects + Engineers, of Auburn has been retained by the Auburn School Department to evaluate the existing Edward Little High School, including the site, to determine the feasibility of expanding and renovating the existing school vs. constructing a new school either on the existing site or on a new site. The evaluation was prepared by Jeff Larimer, AIA, with the assistance of Tom Morrill, Superintendent; Jude Cyr, Business Manager; and James Miller III, Principal.

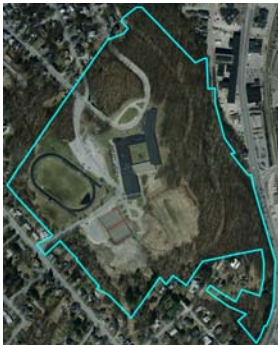
Exhibits A & B

Edward Little High School is located on 56.23 acres in the city of Auburn. The property is bound by residential development to the north, west, and south. The eastern boundary of the property is defined by the Minot Avenue right-of-way.
